JSF-Urban Cruiser2 – battery powered transport device

Limited electrical safety investigation

Report No. 102407157MKS-002

Date: 21 January 2016

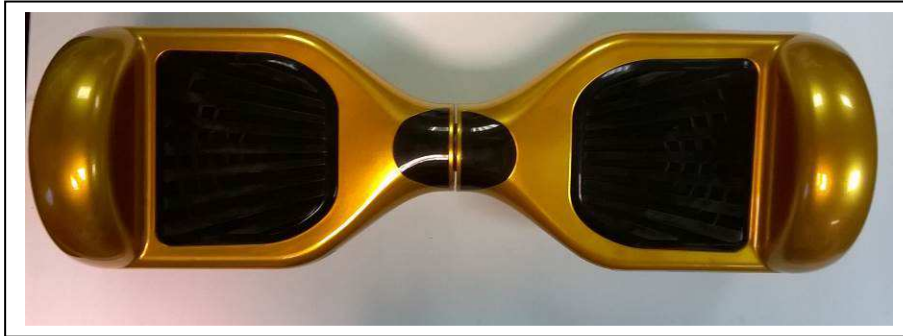
1. Top view of transport device

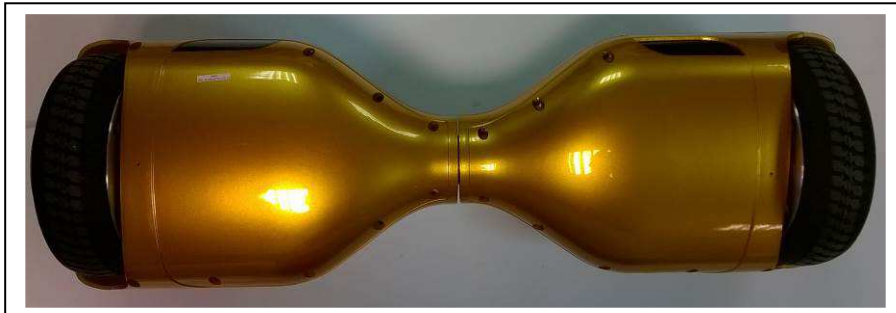
2. Bottom view of transport device

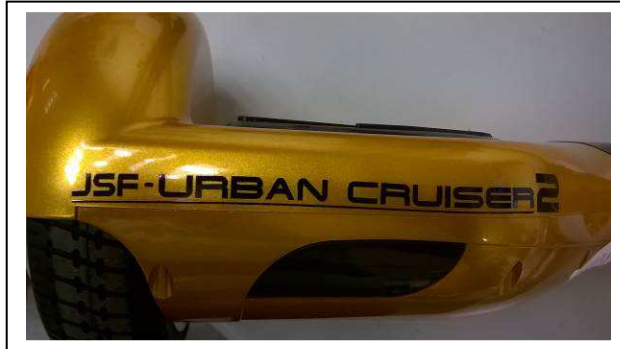
3. Manufacturer and Model

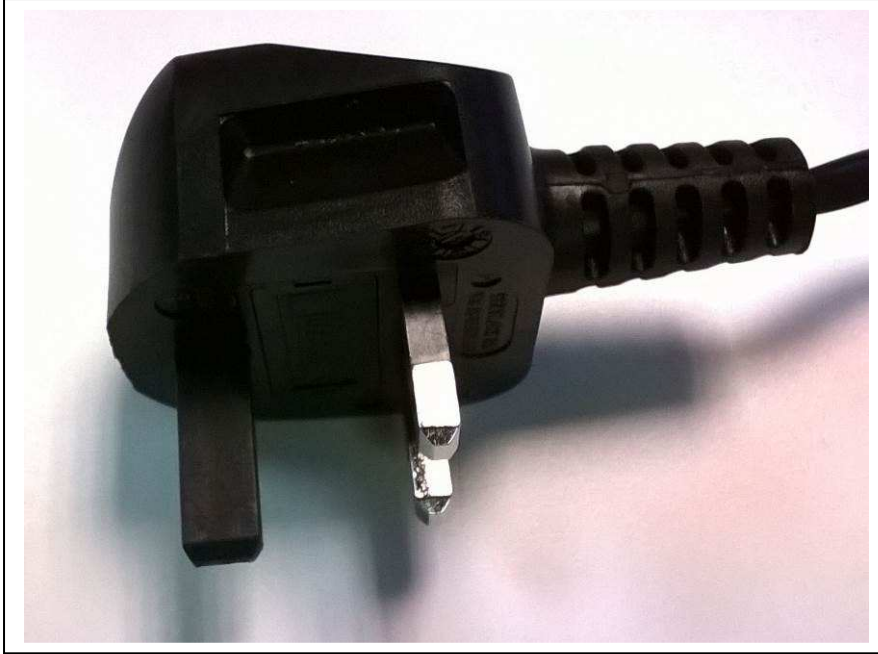
The BS1363-1 mains plug was marked with the BSI Kitemark and displayed the BSI reference number KM/28235, the plug was fitted with a 3A BS1632 marked fuse.

5. Mains plug with insulated earth pin

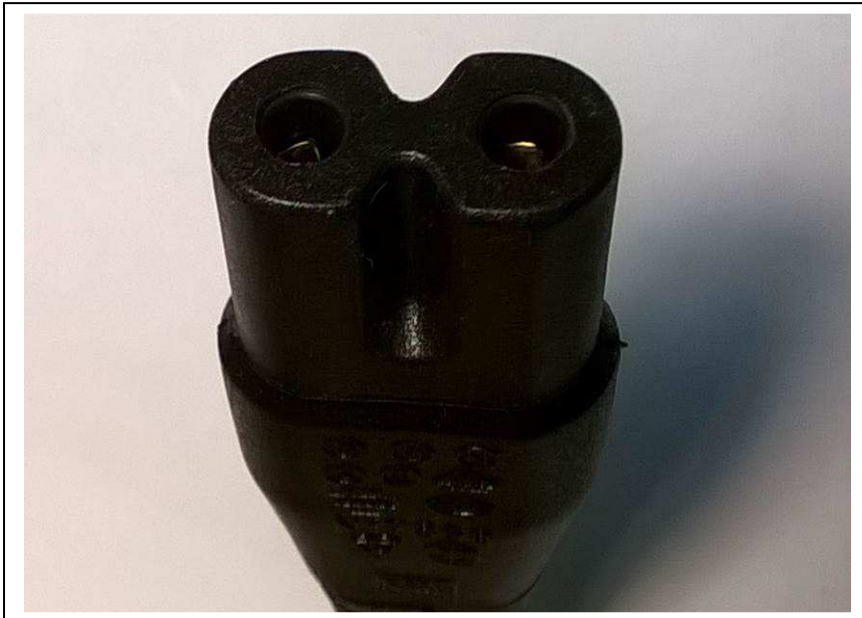
The recess on the female pins of the IEC 60320-1 Type C7 mains connector (see photograph 6) was measured at 3.68mm which is within the specified range of 3.0-3.8mm.

6. IEC 60320 mains connector

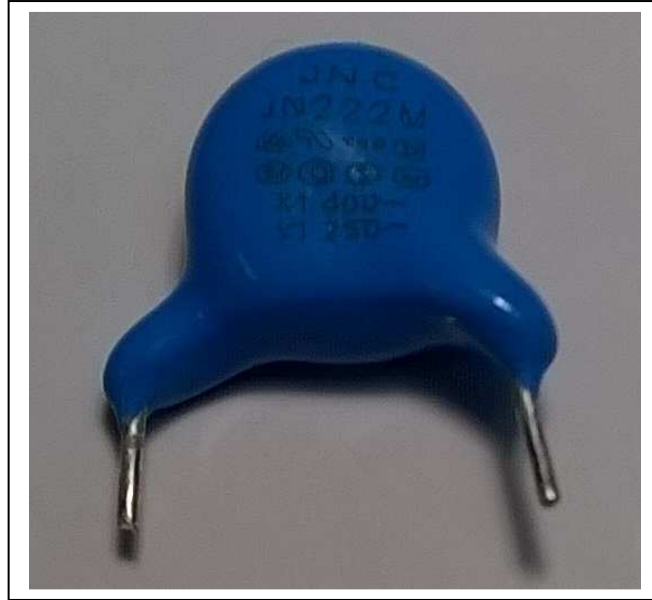
The capacitor across the PCB isolation barrier was marked with a suitable rating, marked as a Y1 capacitor rated at 250V

11. Mains charger Y capacitor bridging reinforced insulation
